Bourgault Air Seeder--Chickpea Seeding

Introduction

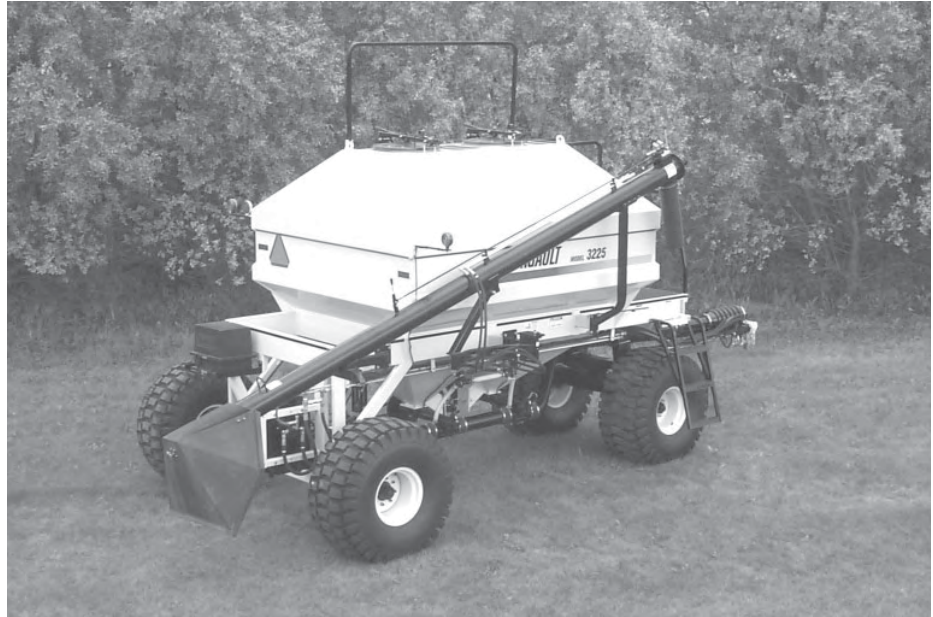
Bourgault Industries provided an air cart/air delivery system to determine operating parameters that will minimize chickpea damage.

A Bourgault 3225 air cart with a PDM metering system and air kit with 5 Quick Inspection manifolds and 50 outlets was used for the test. The air kit was designed for a 40.8 ft (12.4 m) air drill with 9.8 in (25 cm) row spacing.

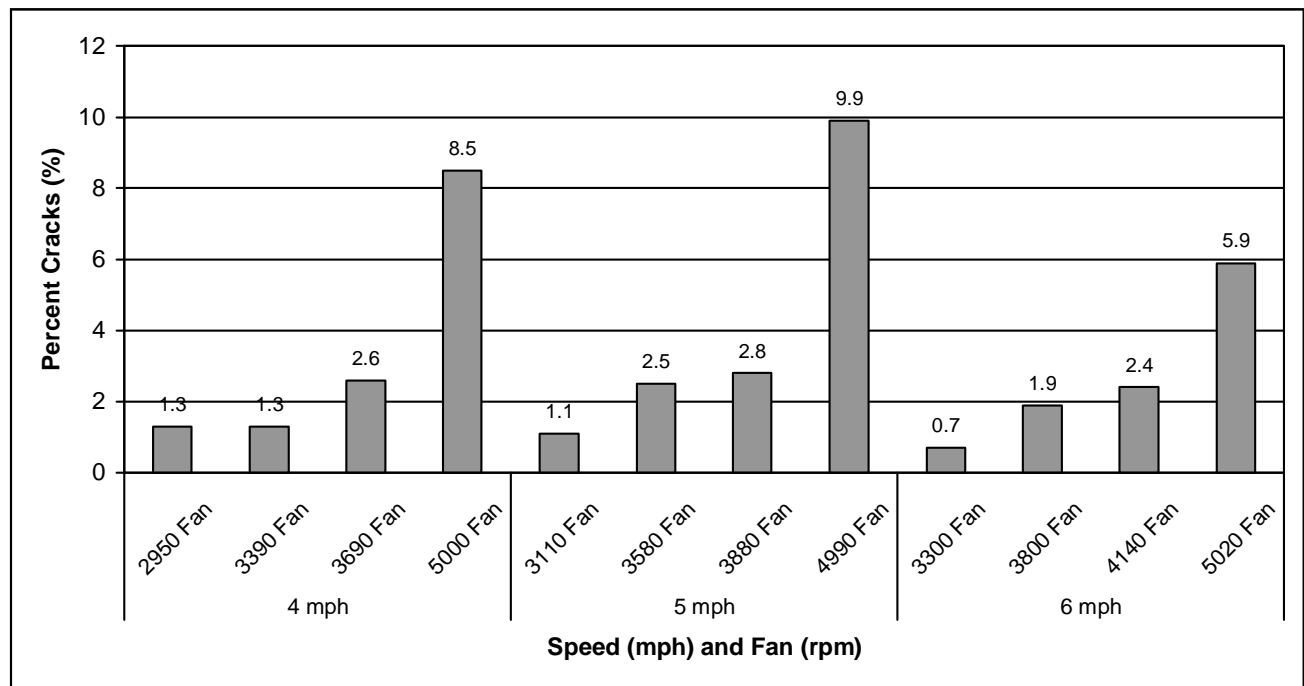
Figure 1. Effect of the Bourgault Ground and Fan Speed on Chickpea Damage.

Chickpea damage with the Bourgault system was very low at fan speeds from baseline to baseline plus 25% (**Figure 1**). At maximum fan speed, which is significantly higher than recommended, the damage was much higher. However, *there would be no reason to run the system at maximum fan speed*. Damage at

base fan speed plus 25% was less than 3% at all ground speeds.

The base fan speed would likely only be used in ideal conditions. The base fan speed plus 25% would be a more typical operating fan speed for field conditions.

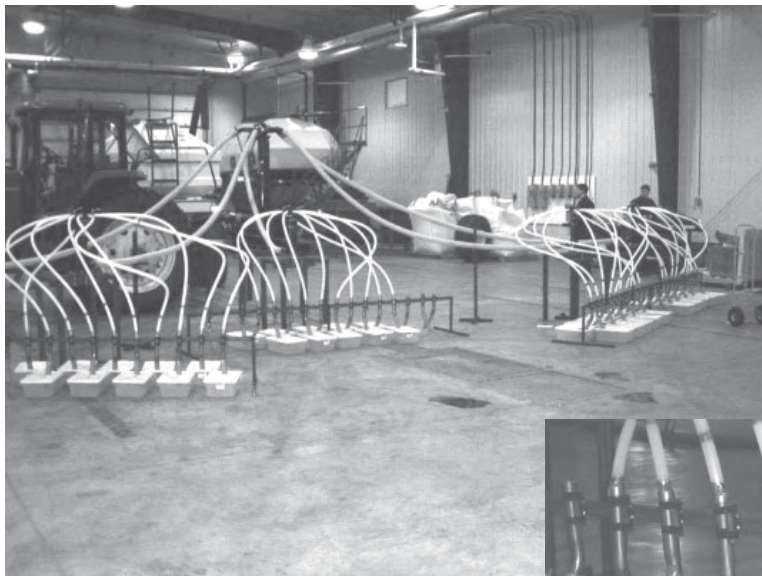
Test set-up.

The seed damage tests were conducted with the air tank/air delivery system on a level surface. The manufacturer’s seed boots were replaced with a “standard” boot to ensure machine performance was not affected by boot design. A rubber hose was attached to the discharge end of the boot to direct seed into plastic catch tubs.

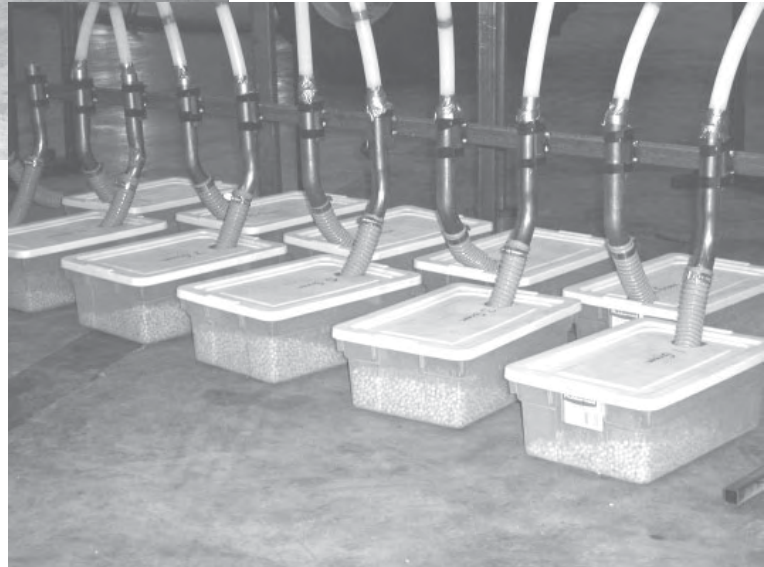
Collection tubs.

method at a simulated ground speed of 4 mph (6.4 km/h). Air tank/air distribution samples were collected in plastic tubs at the end of each delivery hose. Samples were combined from each outlet and divided down for damage assessment.

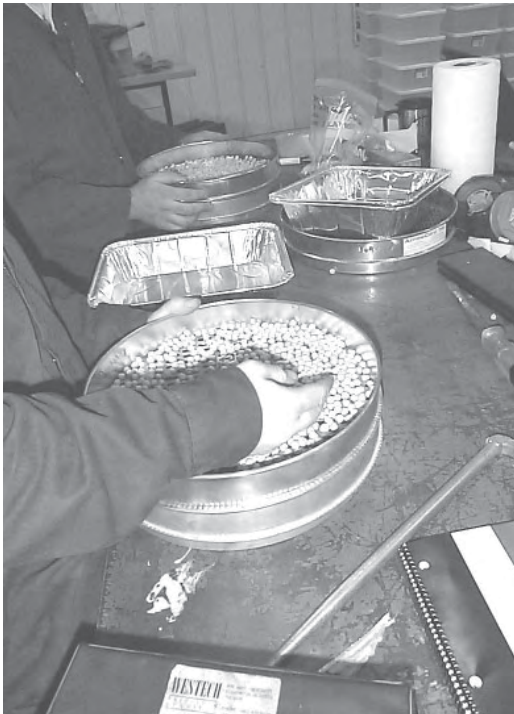
Sorting seeds for damage.

Chickpea damage was evaluated by two different methods. The first method was by visual inspection of physical seed damage including splits, cracks, or any seed coat penetration. Physical seed damage was quantified by removing damaged seeds from the sample and expressing this weight as a percent of the original sample weight. The second assessment method was to quantify hidden damage to the seed. Hidden damage was determined by sending the good, undamaged seeds to an accredited seed lab for germination tests. Total damage was calculated as the sum of percent physical damage plus the percent reduction in germination. Net damage due to seed metering and distribution was calculated by comparing the difference between the physical and germination damage of the treated samples with check samples.
